INDOOR AIR QUALITY ASSESSMENT

**White Street Elementary School
300 White Street
Springfield, Massachusetts**

Prepared by:
Massachusetts Department of Public Health
Bureau of Environmental Health Assessment
January, 2002

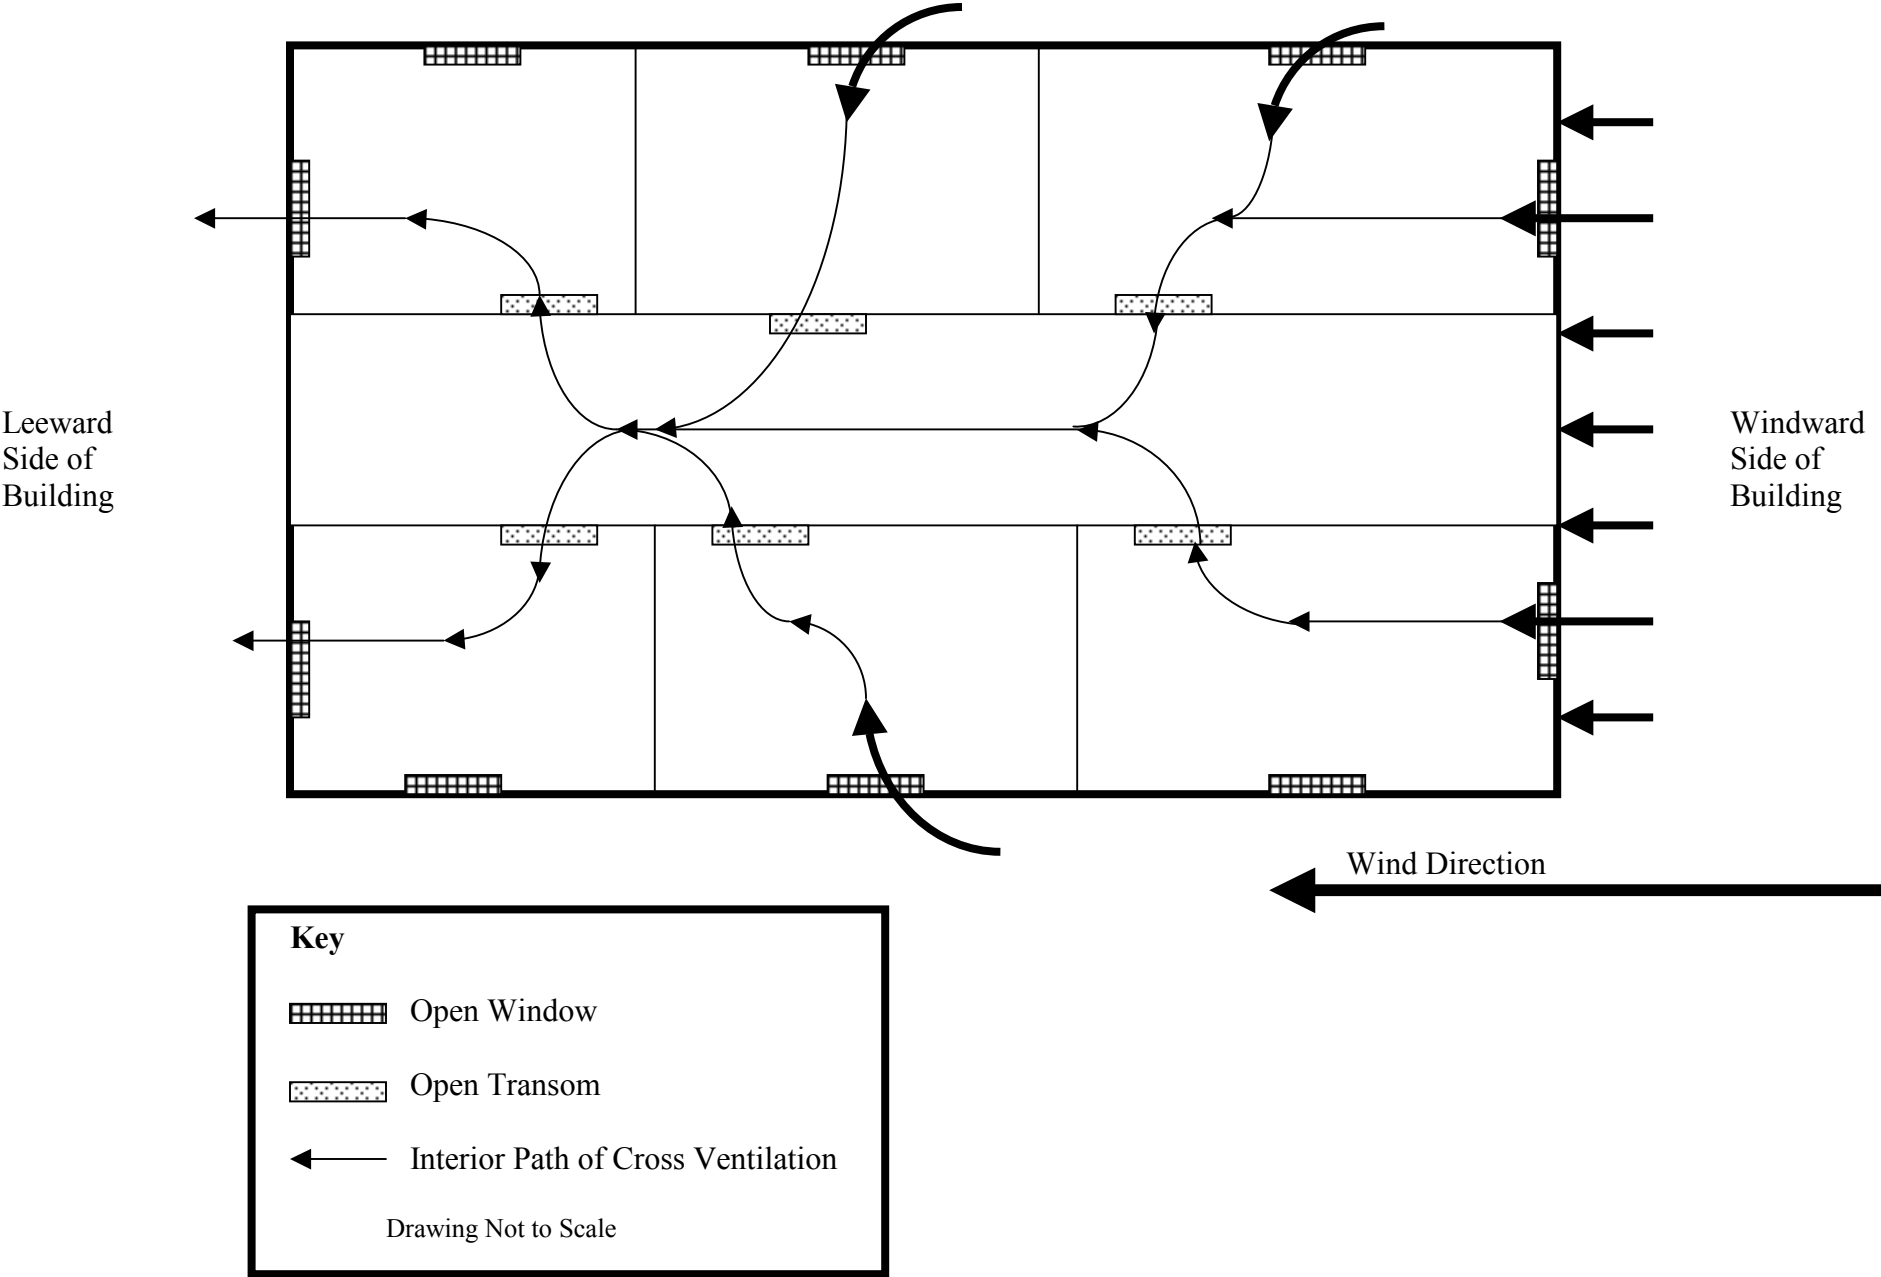
Figure 1

This building was configured in a manner to use cross-ventilation to provide comfort for building occupants. The building is equipped with windows on opposing exterior walls with hinged windows located above the hallway doors. This hinged window (called a transom) (see Picture 5) enables classroom occupants to close the hallway door while maintaining a pathway for airflow. The design allows for airflow to enter an open window, pass through a classroom and subsequently pass through the open transom. Airflow then enters the hallway, passing through the opposing open classroom transom, into the opposing classroom and finally exits the building on the leeward side (opposite the windward side) (see Figure 1). With all windows and transoms open, airflow can be maintained in a building regardless of the direction of the wind. This system fails if the windows or transoms are closed (see Figure 2). Transoms are opened using a chain/pulley system, some of which appeared operable.

Cross Ventilation in a Building Using Open Windows and Transoms

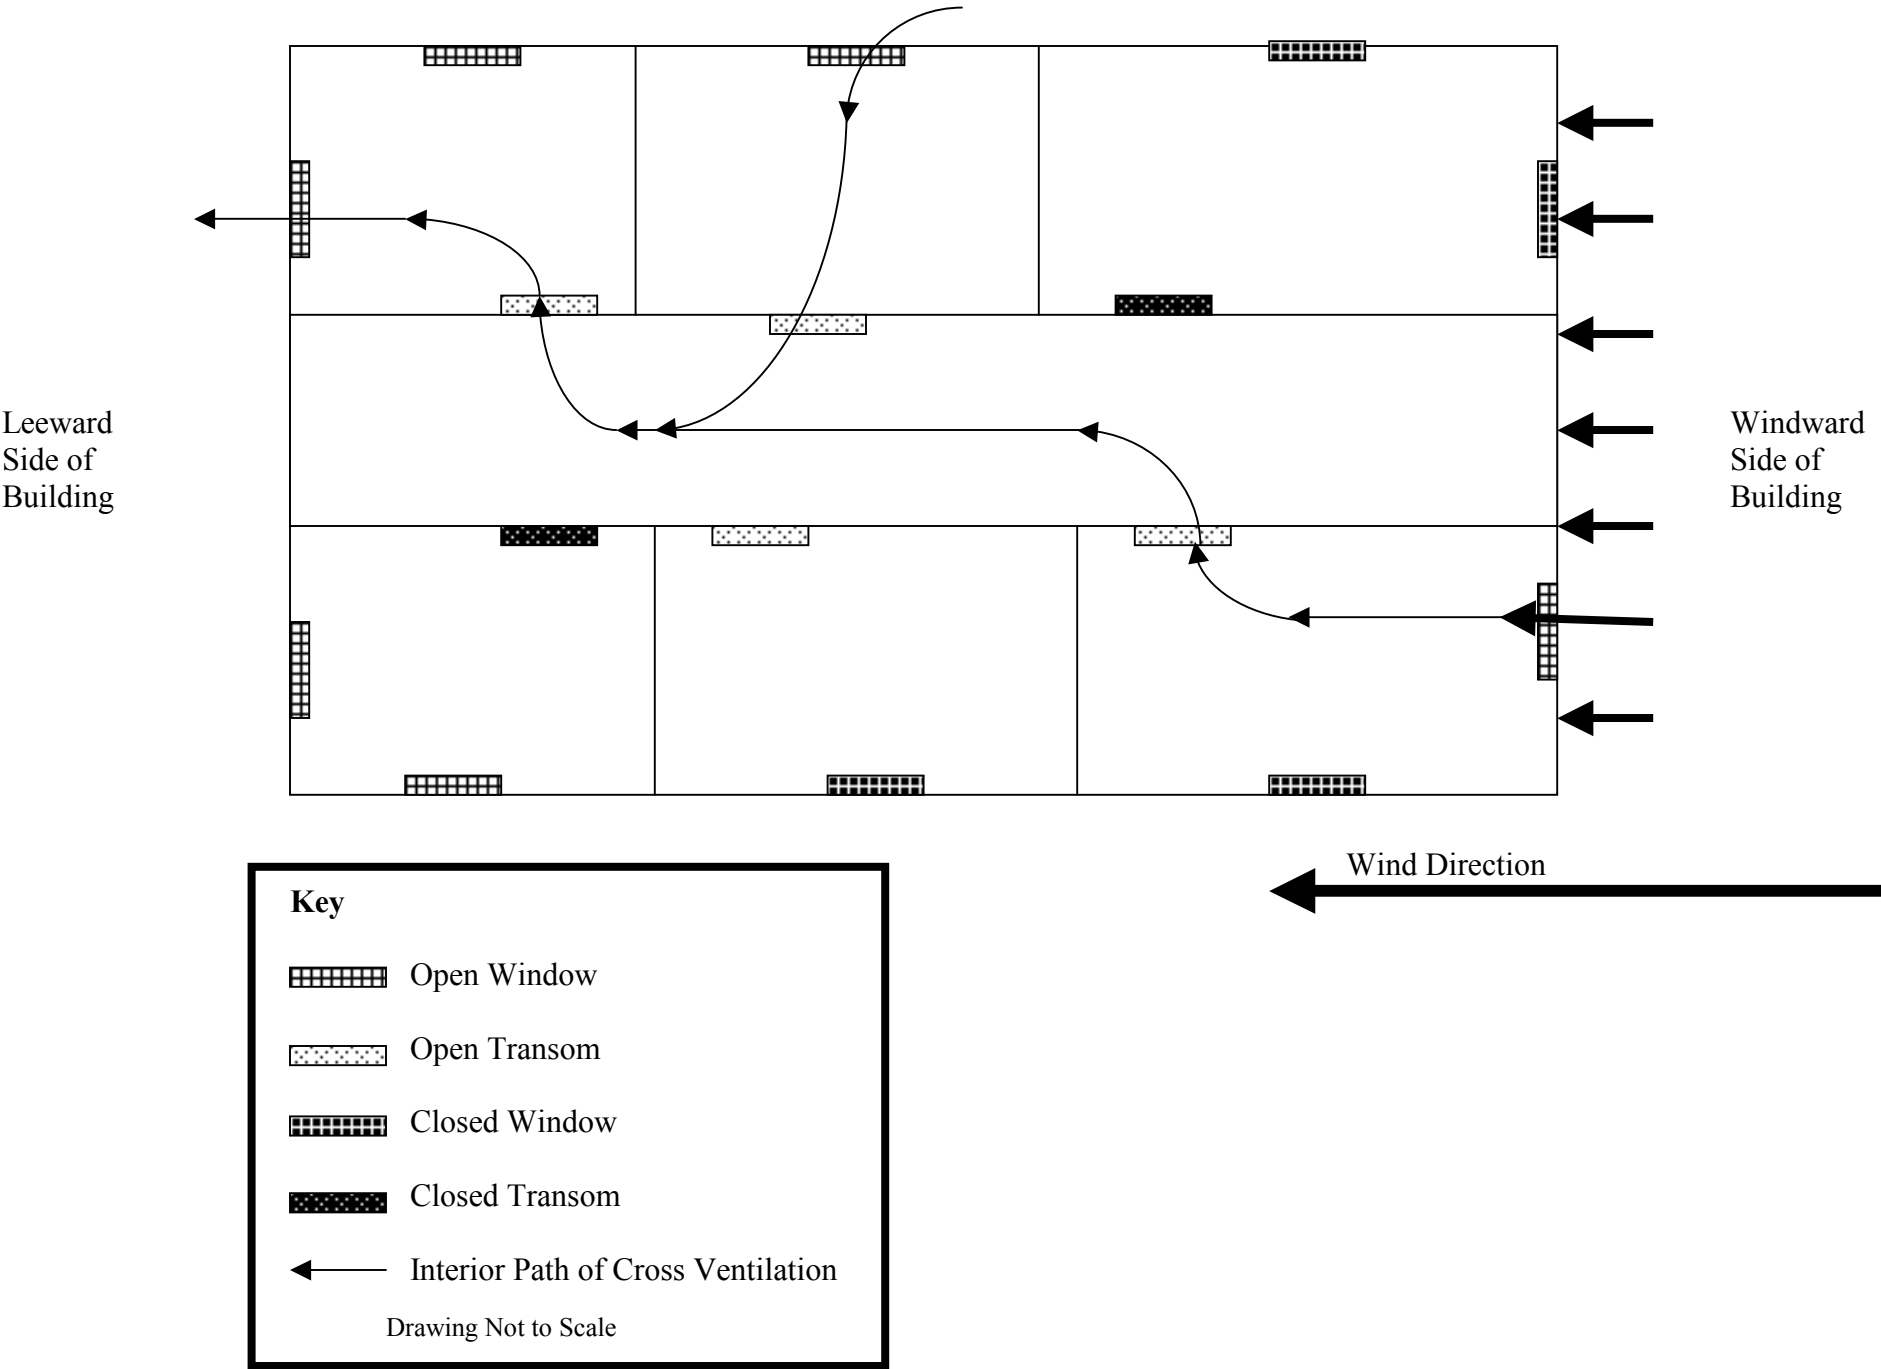
Figure 2

Inhibition of Cross Ventilation in a Building with Several Windows and Transoms Closed
